Case Report

# A Multidisciplinary Conservation Project for the Cavallerizza Courtyard, Palazzo Ducale di Mantova

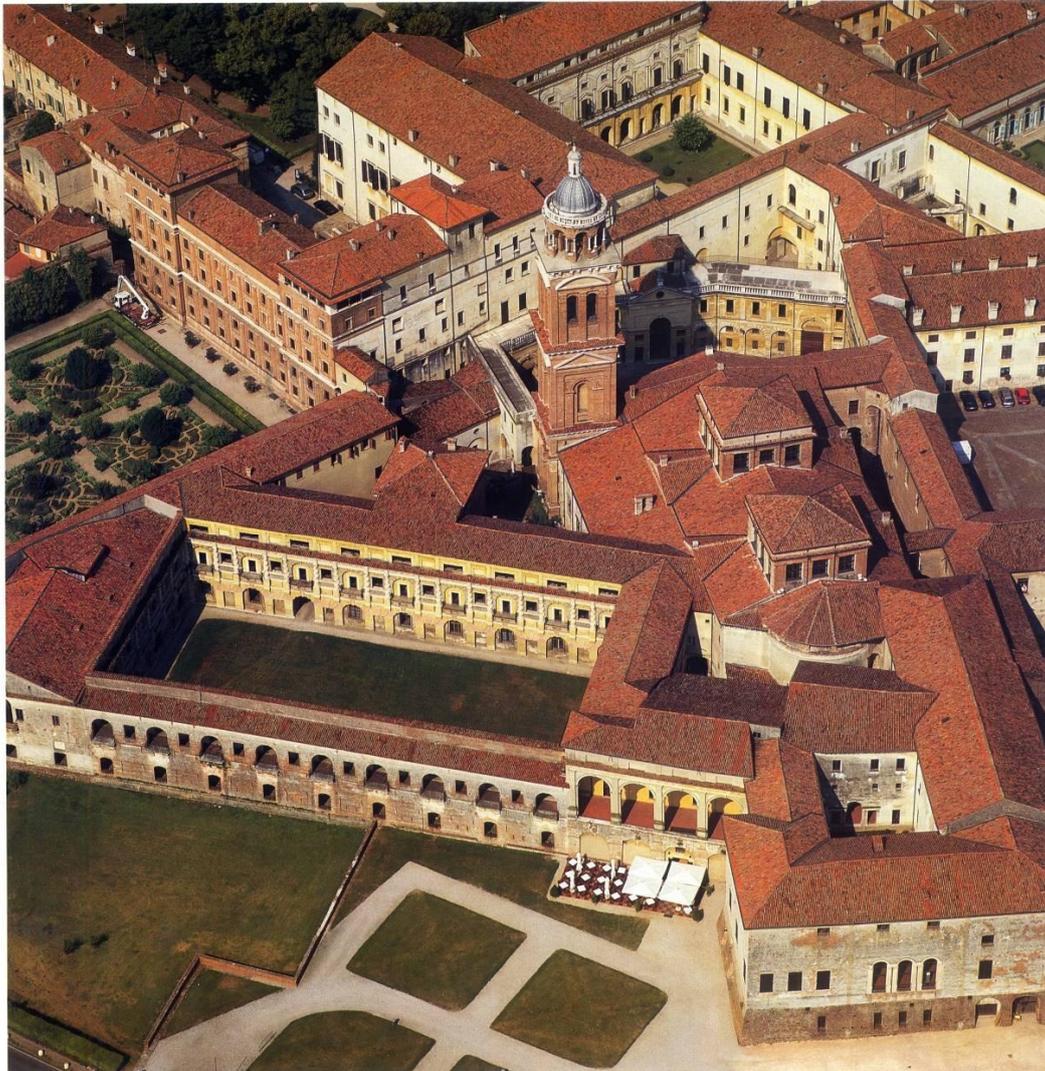
**Figure 1.** Aerial view of the Cavallizza Courtyard.

Palazzo Ducale (Figure 1) presents a varied historical and architectural stratification, strongly linked to the city life. The Gonzagas settled in Mantua from 1328 [1].

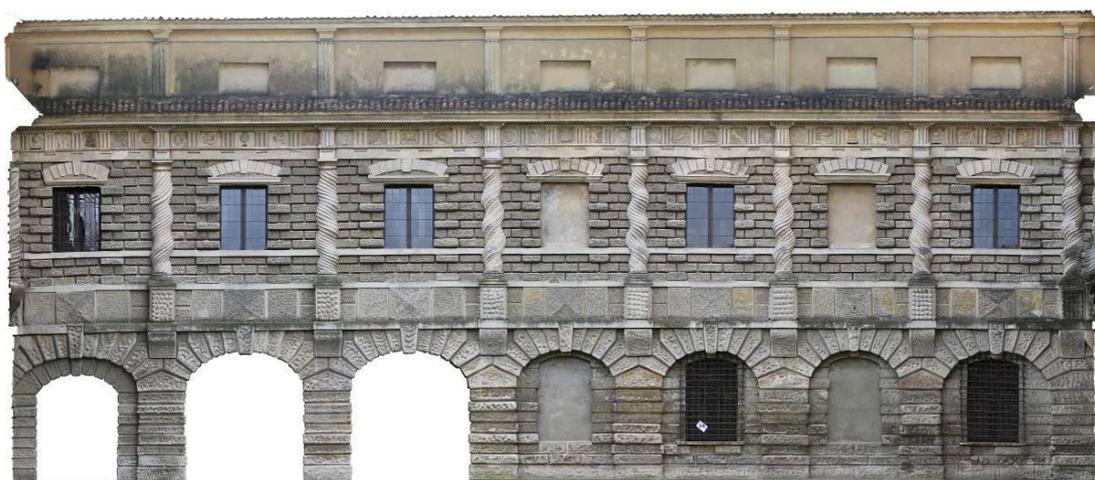
**Figure 2.** Orthophoto of Rustica (elaboration of He.Su.Tech.).

From 1536 the works began on the Rustica (Figure 2), the southeastern front of the Cortile della Cavallerizza.

Despite the apparent homogeneity of the courtyard, each elevation shows independence of construction in terms of thought, organization, materials and processing techniques. Only when all sides are made is an attempt made to unify the design, achieving the current result.

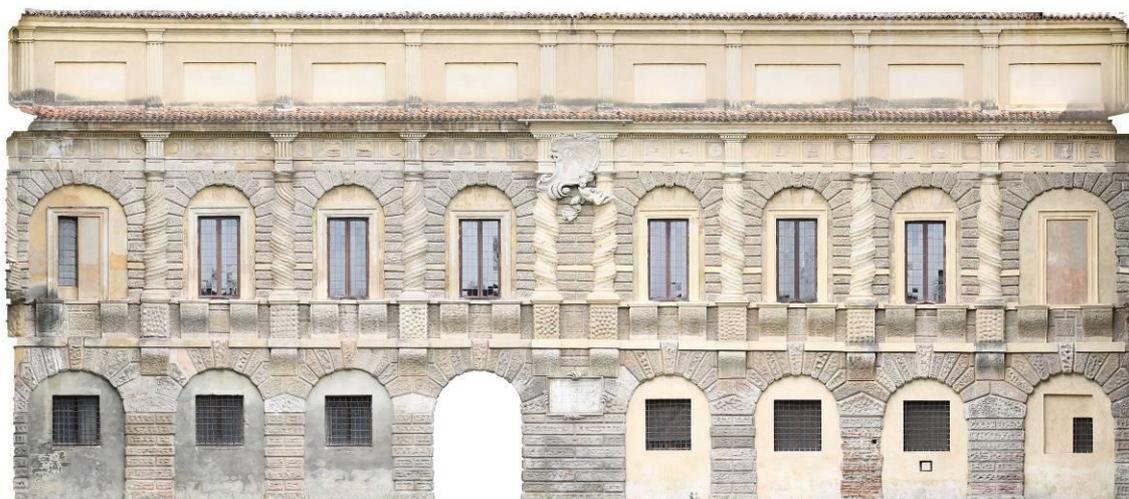
**Figure 3.** Orthophoto of the Galleria dei Marmi (elaboration of He.Su.Tech.).

The “Galleria dei Marmi” (Figure 3) is the second front conceived by Giulio Romano.

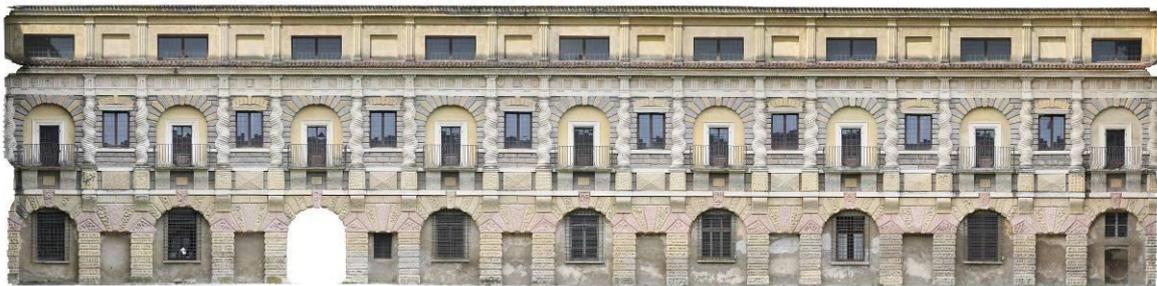
**Figure 4.** Orthophoto of La Galleria della Mostra (elaboration of He.Su.Tech.).

The work of adapting the spaces is interesting. The spans are not regular but their succession does not emerge from the dimensional differences necessary to give a proper solution corner. If in the Rustica the solomonic columns emerge from a solid rusticated wall, here they flank the arches of the original Loggia. Compared to the seven arches of the Rustica, here there are eight. It is interesting to note the difference in height between the floor elevations of the Gallery of the Marbles and the “Galleria della Mostra” (Gallery of the Exhibition): if it corresponds to the level of the windowsill for the former, it equals the floor level for the latter [7]. In the “Galleria della Mostra”, after the death of Giulio Romano, the architect Bertani tried to introduce different solutions from those conceived by Giulio Romano [8]. However, not the archival data but the information obtained in the restoration of the early 20th century have clarified the construction (Figure 4) [9].

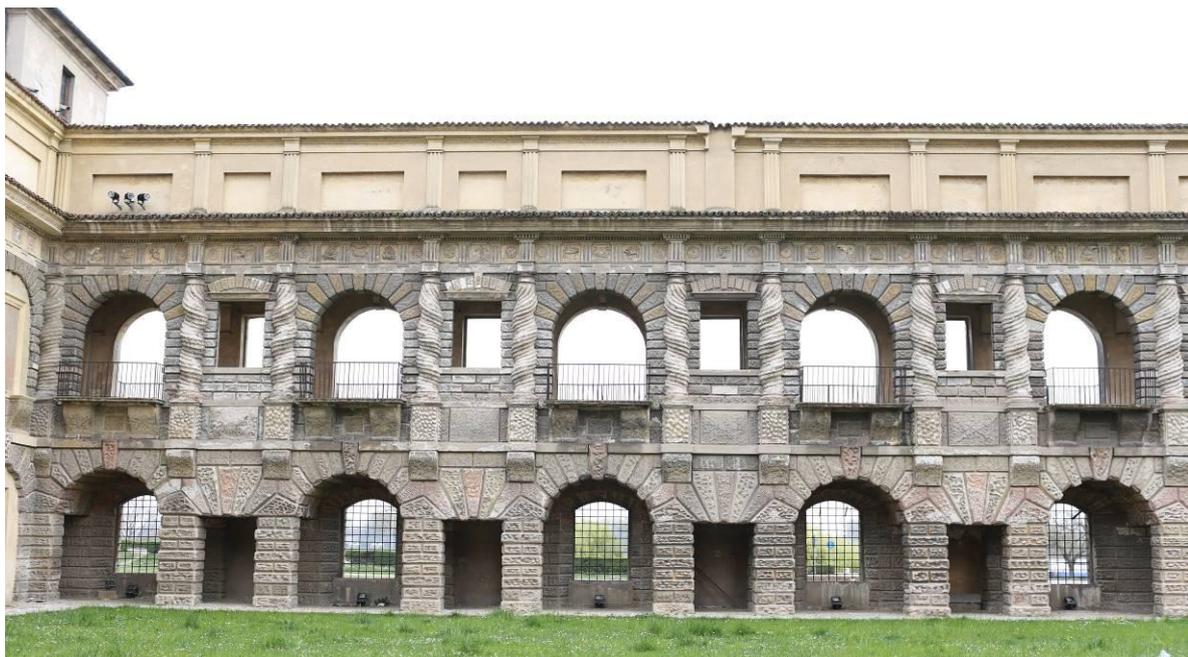
**Figure 5.** View of the lakeshore Loggia.

The “Corridore” is the front that closes the court. Our observations provide interesting information on its construction (Figure 5). The direct examination (on the occasion of the first restoration) of the masonry confirms the hypothesis that the new loggia was being added to the existing city walls. The pillars of the external side of the portico have been obtained “by subtraction”, that is, by demolishing the thickness of the wall. In the demolition, arches were obtained. On the contrary, the inner side of the porch is completely new. From the outside of the courtyard the anchoring ties are evident, positioned to weld the two parts into a single resistant element.

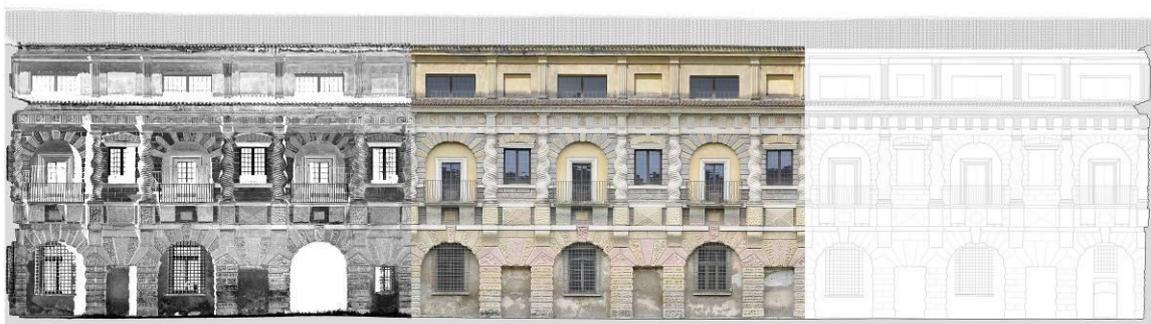
**Figure 6.** Digital photocomposition to describe the different stages of the geometric survey, from the point cloud (in greyscale on the left), to the orthophoto (centre) to the vector drawing (on the right).

In the survey of the courtyard (including the wall surfaces and the gallery) it was decided to integrate laser scanner with photogrammetry (Figure 6) in order to have a complete dataset that met both the needs of a geometric description of the building (for the architectural survey) and its qualitative description, from which to extract information related to the materials used and the state of preservation.

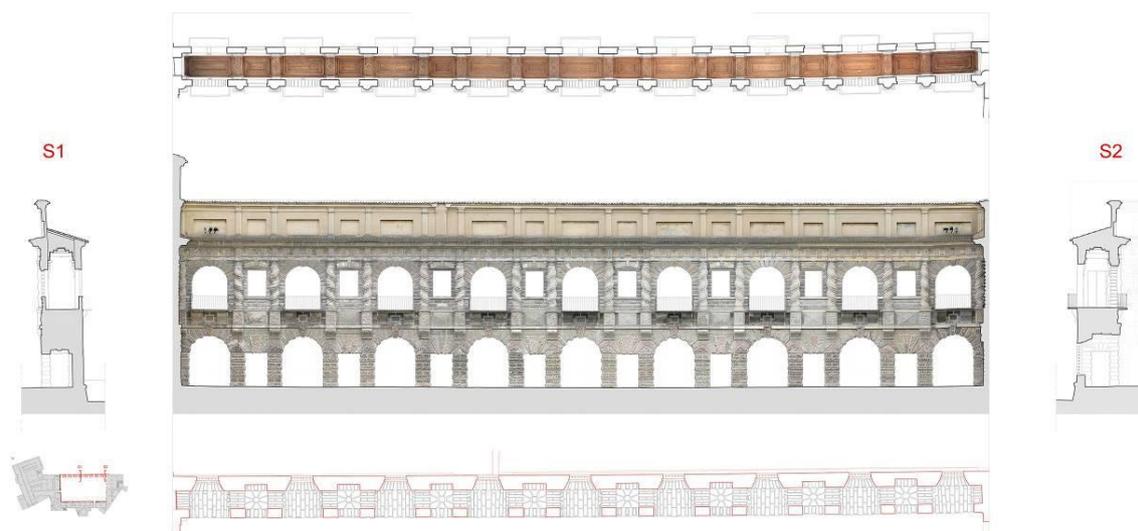
**Figure 7.** The lakeshore loggia described by different survey outcomes: two transversal sections (S1 and S2), the orthophoto of the façade (centre) and the opposite map of the ground floor (centre bottom) and first floor ceiling (centre top).

The acquisitions were made following the logic of the photogrammetric strip, but with a longitudinal and transversal overlap of about 70–80% to allow greater recognition of significant points to be used in the orientation phase. In addition to the frames normal to the facade, used in the strip, frames with an inclined axis were acquired, with the aim of stiffening the acquired geometry; this was also dictated by the elongated and homogeneous geometric shape of the building itself, which could have led to drift effects. Also, in the case of photogrammetry, targets (encoded by the software Agisoft Photoscan St. Petersburg, Russia—now Metashape) were acquired by topographic means that allowed us to georeference the photogrammetric model in the same system. The photographic acquisition was carried out on several levels to try to overcome the undercuts caused by the rustication and decorative elements; the photos acquired are of the Exhibition Gallery, the Galleria dei Mesi, and by the Corridore (the lakeshore Loggia) that separates the courtyard from the lake.

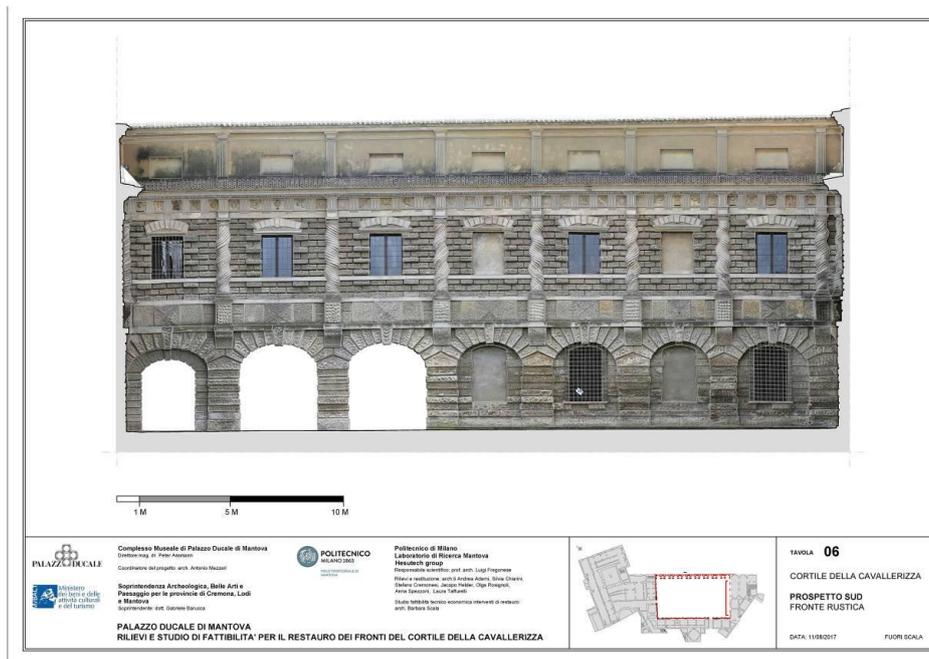
**Figure 8.** The final outcome of the Rustica at the scale of 1:50: the elaboration is the overlapping of the Orthophoto and the vector draft.

At the end of the acquisition phase, all the data (as mentioned above, included in a single georeferenced database) were imported in the Autocad environment and the design was carried out at a scale of 1:50 (Figure 8). At the same time, the orthophotos of the facades (internal and external) and of the false ceilings of the Lakeshore Loggia (Figure 7) were also processed, not only to obtain a product to be used in the geometric description of the factory, but also to support the analysis of the materials and degradation.

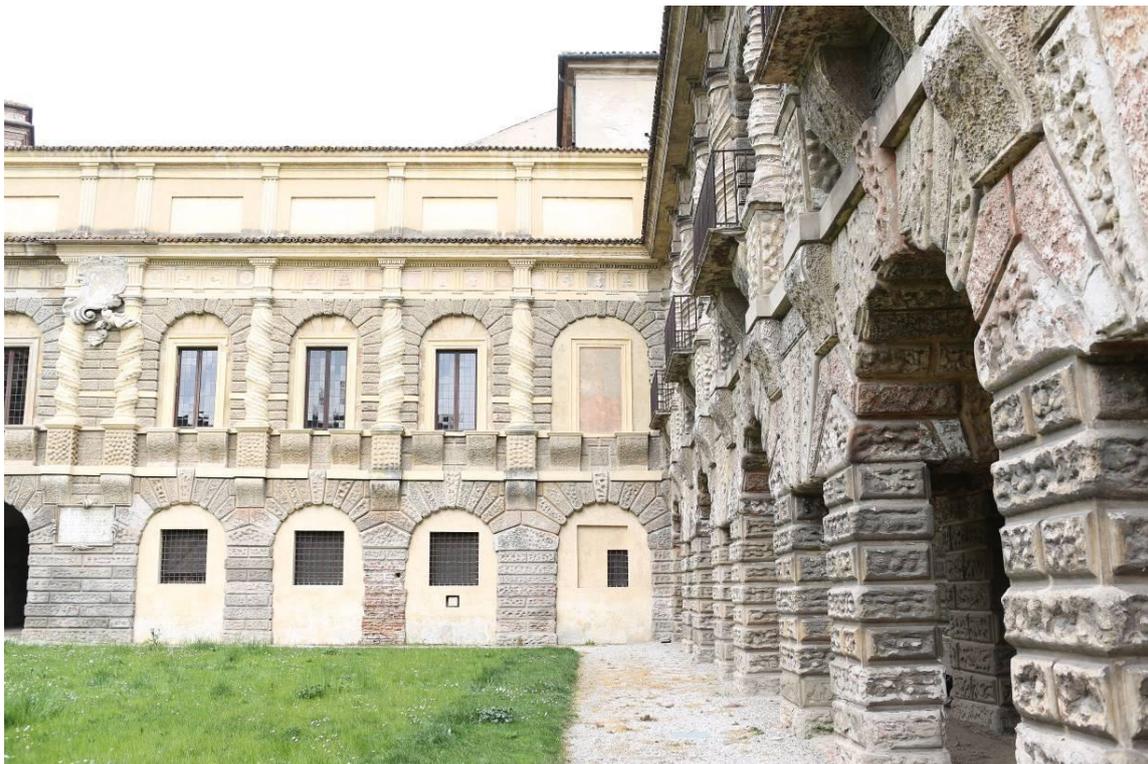
**Figure 9.** Detail photo with evidence of the bocciarda technique.

In the spans attributed to Giulio Romano's workshop, the ashlars show a more decorative style. We can find ashlars worked alternately with a fine bocciarda technique and ashlars worked with a coarser style (Figure 9).

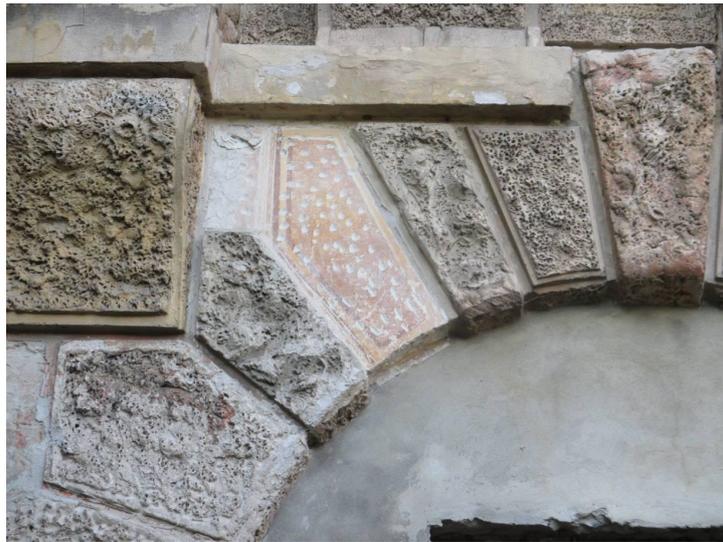
**Figure 10.** Detail with different ashlars.

An interesting detail is a false ashlar painted on the plaster in the north elevation, on which a subsequent mortar ashlar was then applied. The plaster finish was tapped on the decorated surface to ensure the adhesion of such superficial ashlar (Figure 10).

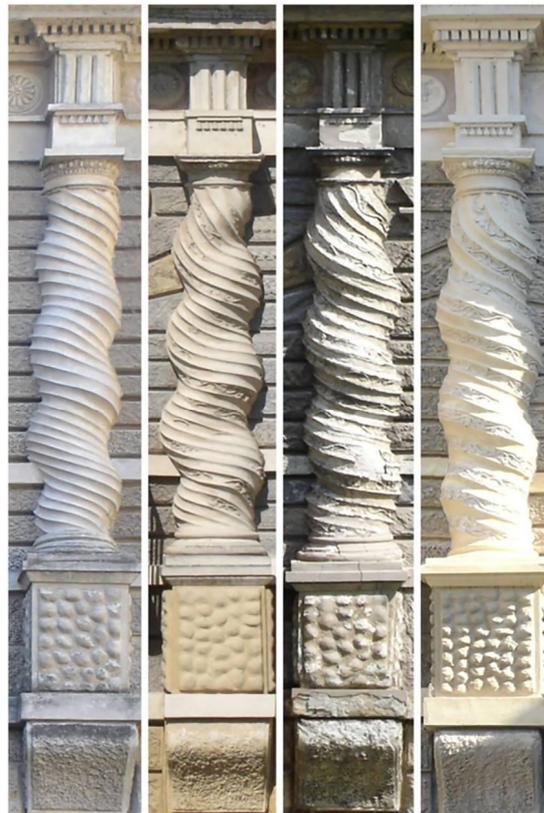
**Figure 11.** A comparison of the different columns of the courtyard.

There are numerous elements of differentiation between the columns:

1. the columns of the side of the Rustica appear thinner and have a more sinuous movement of the rings, while the shaft of the columns of the longer sides are thicker;
2. only the columns of the south elevation are entwined with vine shoots, while in the rest of the elevations vines, bunches of grapes and other types of leaves are mixed up;
3. some of the vine shoots run along the flutings, following a straight line (in some columns of the south elevation), while others follow a sinuous line (especially in the north and west elevations);
4. the columns in the west and north elevations present two branches that constantly intertwine, drawing oval shapes;

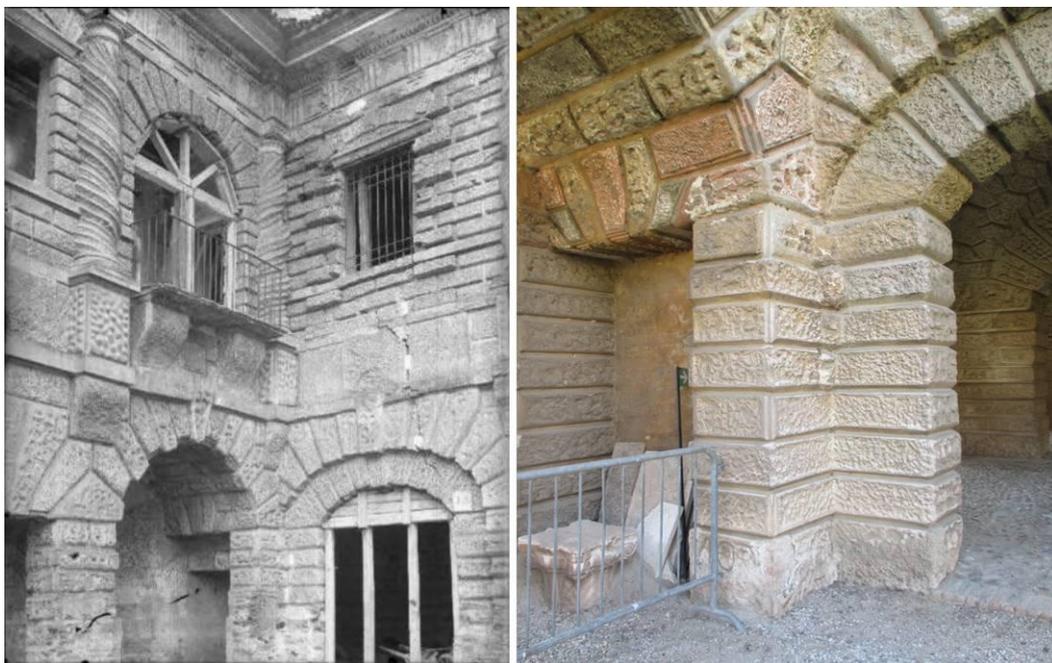
**Figure 12.** Corner solution of the upper part (image on left: 1989) and of the lower part (today).

Observation and study of corner solutions help us to understand the architectural structure (Figure 12). The portion facing the lake was placed over the body of the Rustica, previously built by Giulio Romano. The junction between the inner wall of the Corridore and the Rustica shows a single half-column. The pilaster that completed the facade of the Rustica was hidden by this front (it can just be seen from the main floor of the loggia).

In the lower register, the pillar of the first arch on the lake side, inevitably, is embedded into the opening of the Rustica arcade. This inconsistency was corrected by inserting a further inner arch into this first span on the left. The expedient determines the creation of an angular pillar that, if it does not completely conceal the anomaly, at least attenuates its evidence.

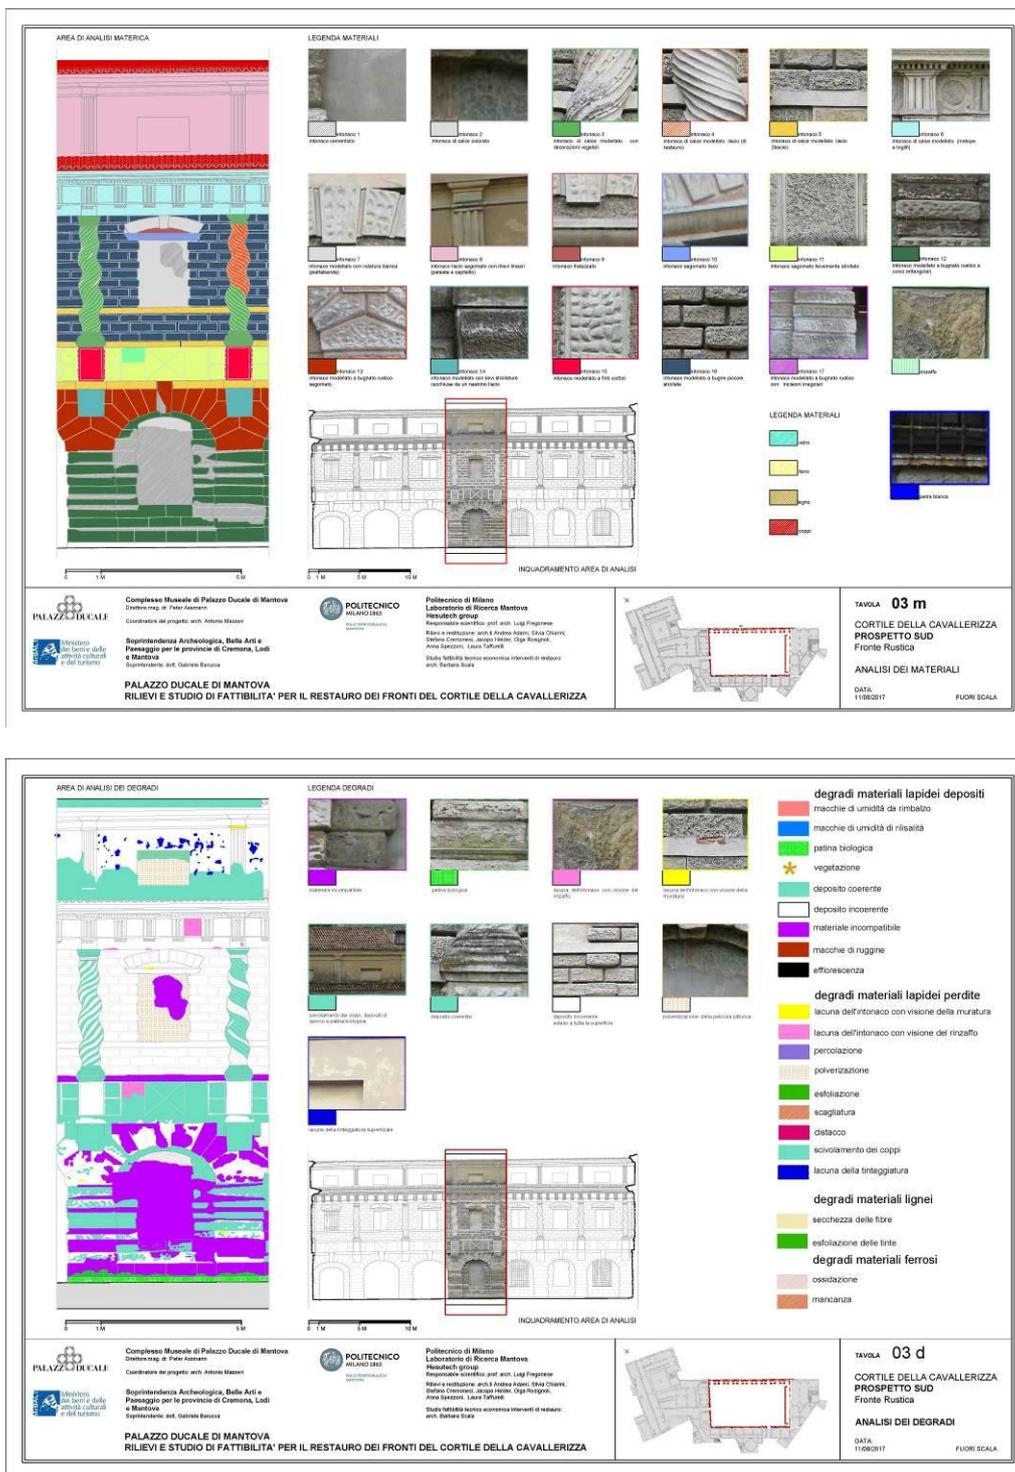
**Figure 13.** Thematic analysis of the project (on the top, a material survey; on the bottom, a degradation survey).

In light of the different characteristics of the elevations (as highlighted above), we have tried to organize the project work, giving value to the differences found (Figure 13).

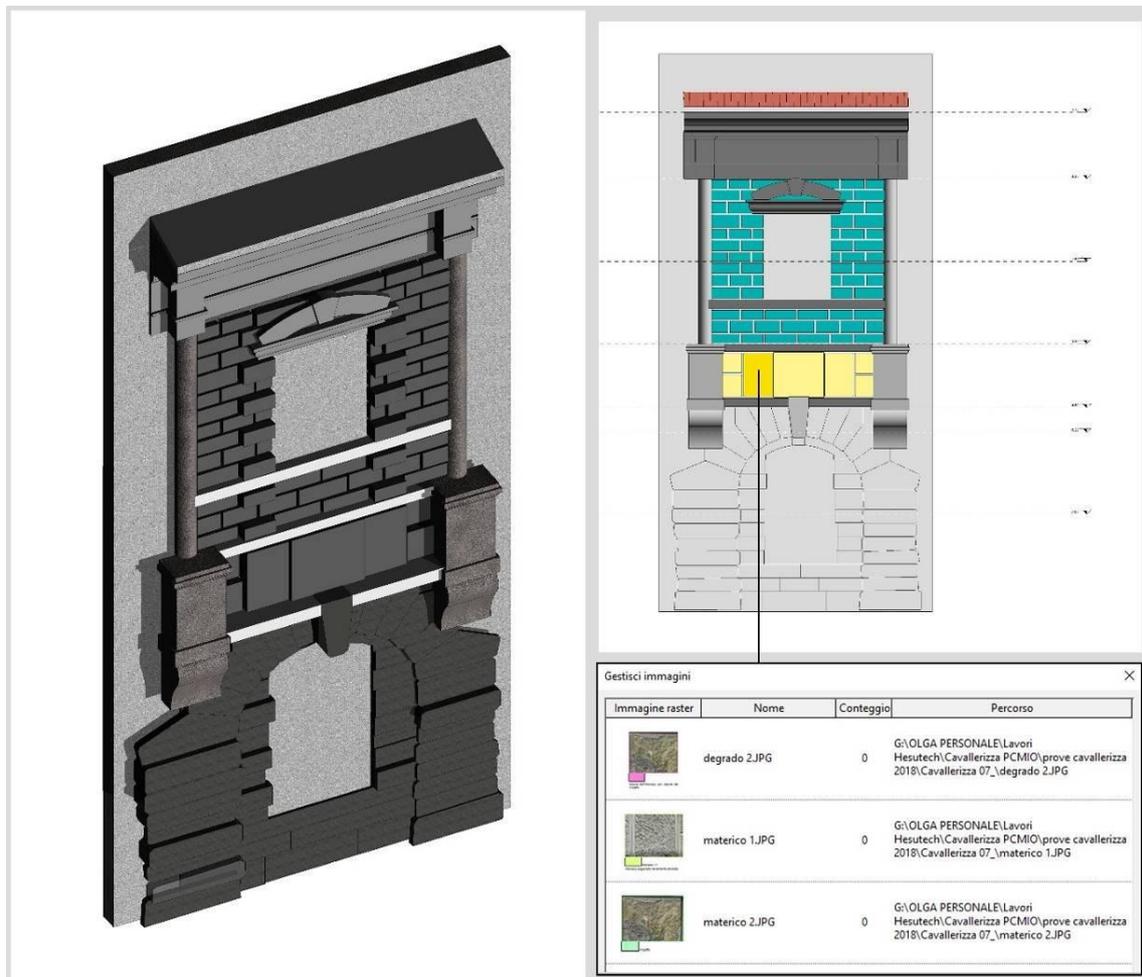
**Figure 14.** Example of a general section of the Cavallerizza façade with the scheme for the different elements positioned on the surface of the main floor (approximately the material classification analysis) and of the string-course frame.

The example shown in Figure 14 illustrates the three-dimensional object, the scheme for the different elements positioned on the surface of the main floor (approximately the material classification analysis) and the string-course frame. One of the quadrangular panels shows the power of this tool: information on the material and the damage (from two different sources) appear together in the description of the element.
